Manhole Inspection Summary

Manhole # S21M1_004MH

Insp Date: **4/30/08 9:49 AM**

Location Address: **2135 hollins ferry-patapsco shopping center**

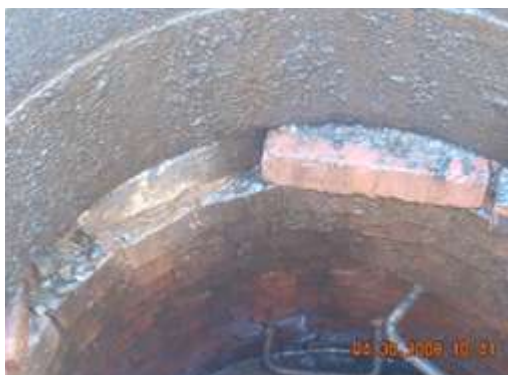
Defect 4

Frame Offset: **1.5** (in.) Condition: ☐ Sound ☐ Cracked ☒ **Leaks**

frame adjustment/metal insert leaks

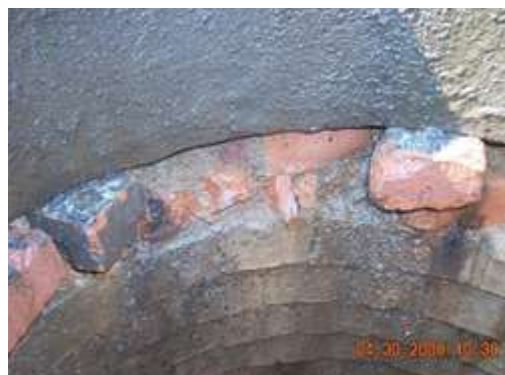
Defect 3

Condition: ☐ Sound ☒ **Cracked** ☐ Root Intrusion ☒ **Loose Brick** ☒ **Deteriorated**

crack and deteriorated chimney bricks

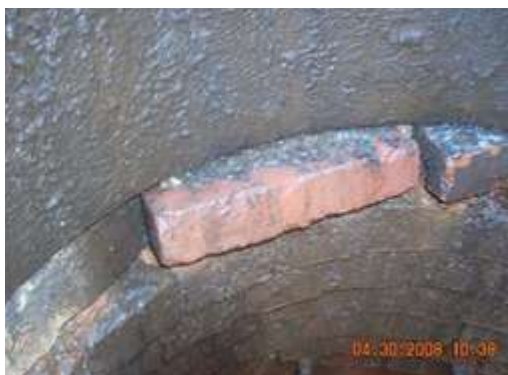
Defect 2

loose chimney bricks

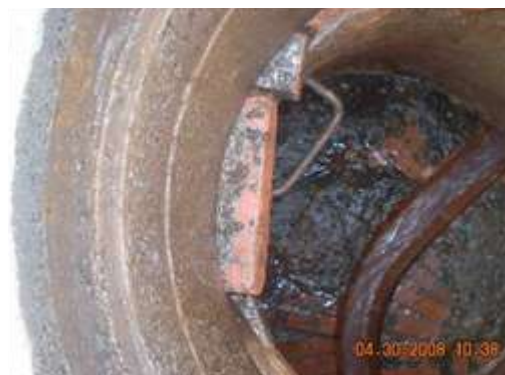
Defect 1

frame offset

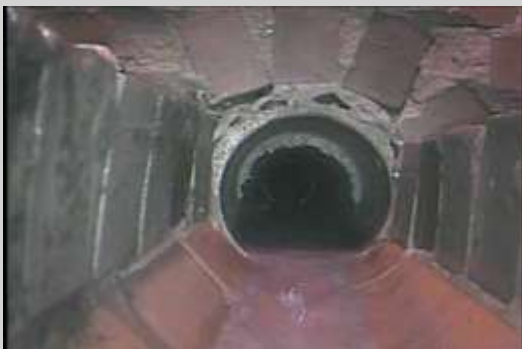
8 O'Clock Inflow

Pipe Height: **6** (in.) Rod and Bar (Angled)
Pipe Material: **Clay** ☐ Pipe Lined
Invert Depth: **6.04** (ft.) Flow Characteristics: **Slow**
Deposits: ☐ None ☐ Mud ☐ Sludge ☐ Debris ☒ Grease
Silt Depth: **1** (in.) Deposits Extent: **Light**
Infiltration: **None** Pipe Seal Cond: **Cracked**
